Damage Survey and Assessment of Fort Worth Tornado, 28 March 2000

Prepared By
C.W. Letchford, H.S. Norville, and J. Bilello
Wind Science & Engineering Program
Texas Tech University

Submitted to
National Institute for Standards and Technology
August 2000

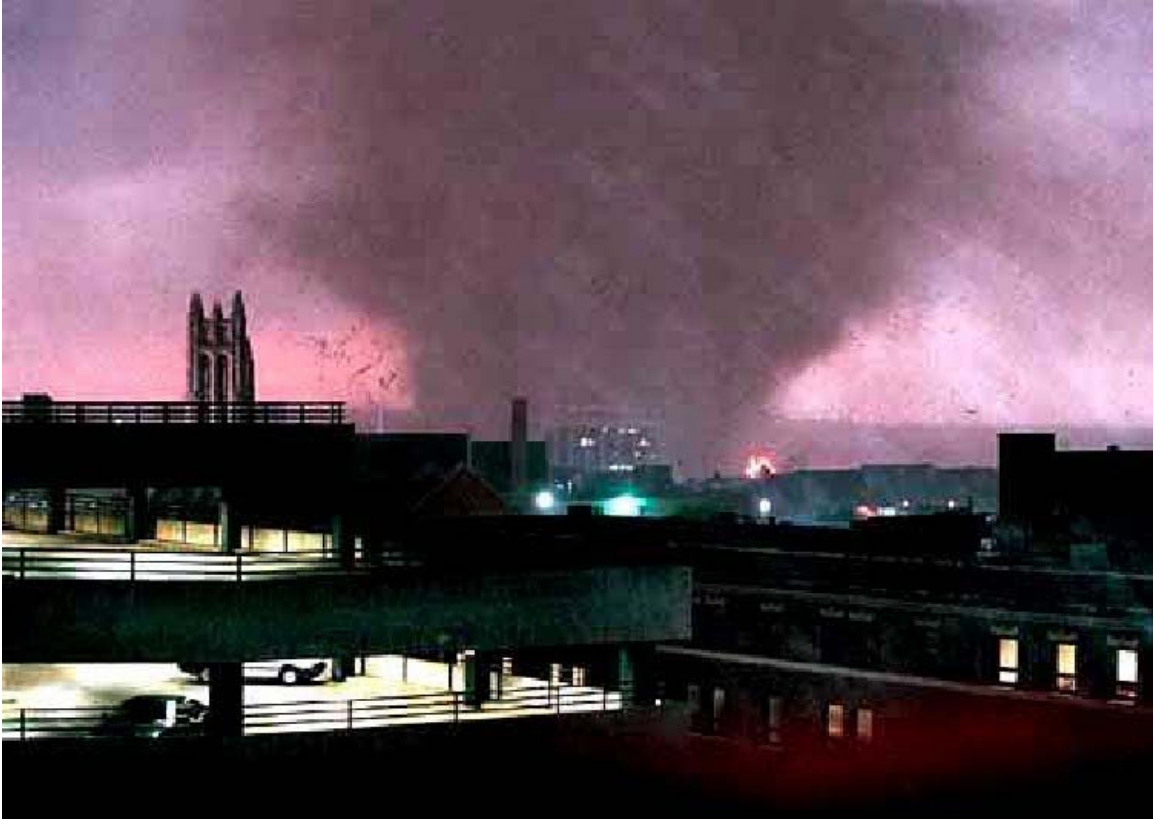
Figure 4. Fort Worth tornado approaching Mallick Tower. Towers of First Methodist Church on left. Significant debris is evident in the flow field. (source: Fort Worth Star-Telegram)

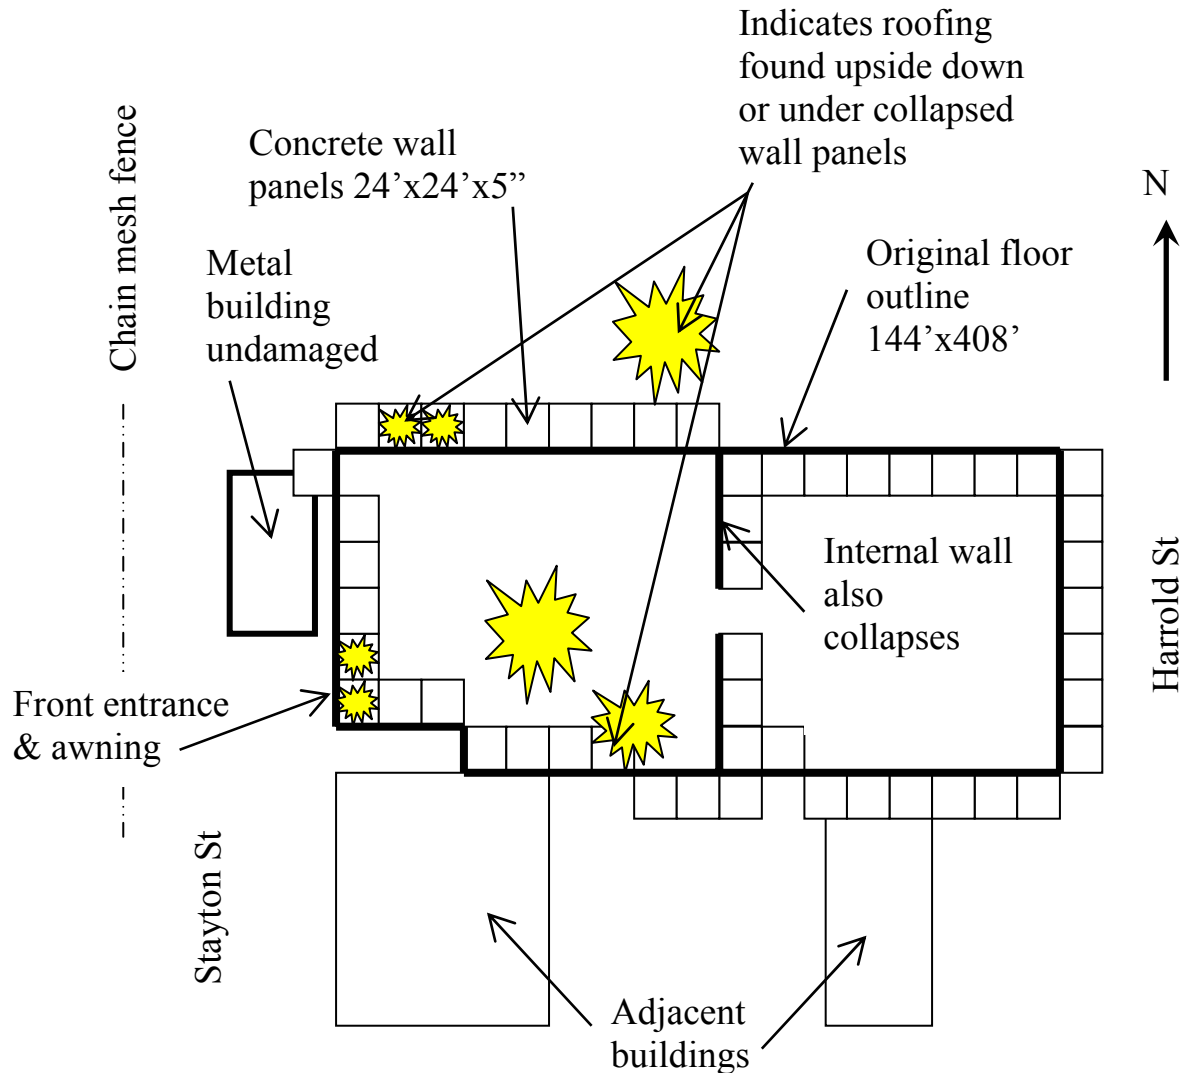
Figure 7. Schematic of damage to Sweet Shop Factory.

The Sweet Shop Factory lay between Stayton and Harrold Streets, just north of West 6th Street. Constructed of tilt-up concrete wall panels, this building suffered catastrophic failure and generated a large amount of debris. Figure 7 shows a schematic of the collapsed state of this building. The debris varied in size and weight from portions of tar covered roofing insulation to full 20'x 2' sheets of metal roofing with the former observed approximately one-half mile to the SSE on the fifteenth floor of Trinity Terrace facing Fournier Street, just south of West 10th Street. The larger roofing sheets were observed on the ground on Fournier Street between West 7th and West 10th Streets and on the seventh floor of Trinity Terrace.

- The building had several openings; a front entrance safety glass single door in the southern end of the western wall and loading bays in the middle of the northern wall and the eastern end of the southern wall. These openings were sealed as the tornado hit and appeared to remain so during the building's collapse. Thus, it is not expected that internal pressurization lead to failure of the roofing.

- The wall panels in the vicinity of the roofing failure were exposed to the full windward pressure and the full negative pressure that removed the roofing.

By and large, the concrete panels remained intact upon falling, but the three fillet-welded joints (~4" long at 6' spacing) up each side between adjacent panels failed. This failure would have occurred after the loss of the roof and during the fall of the wall. The concrete wall panels had similar short fillet welds at their bases and some of these showed significant corrosion. The upper cords of the roof trusses were tack welded to a metal plate set into the top of the concrete wall panels. It is anticipated that this connection failed once the walls began to fall. Some cases failed as the roofing and trusses were removed intact, as evidenced by the upside down trusses toward the middle of the building.

Nine staff, members of the cleaning crew, were lucky to escape with their lives. They had attempted to move away from the southwest corner, which was fortunate, as this corner collapsed inwards.

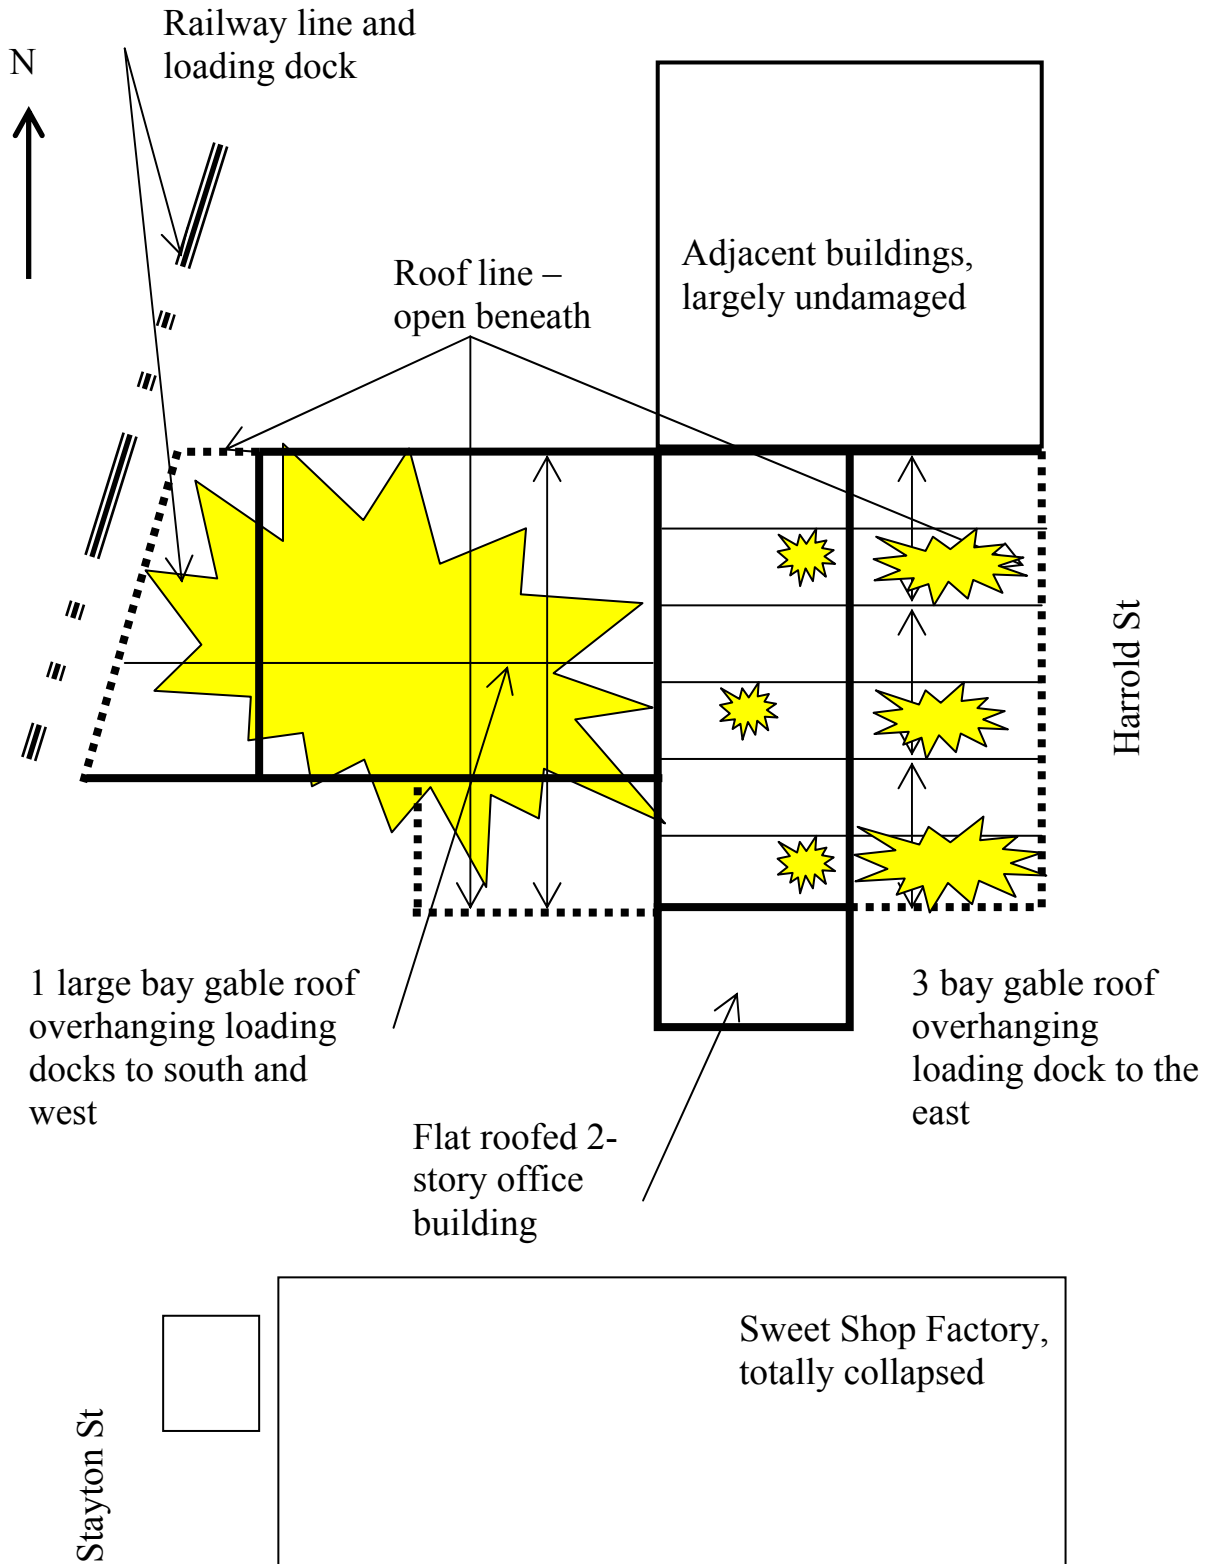
Figure 8. Schematic of damage to Johns Manville Warehouse

The western half suffered catastrophic collapse, while the eastern end appeared to suffer only loss of roofing. The postulated failure mechanism is as follows:

- The northern wall fell inward to the south and also suffered failure of the column-base connection, this time spalling the concrete plinth. This was most likely a result of the frames falling.

- The southern wall collapsed more or less in the plane of the wall towards the east.
- It is expected that large uplift forces were also exerted on the overhang to the southern loading bay as wind was directed from the west and the south during the passage of the tornado, as evidenced in the collapse of the adjacent Sweet Shop Factory.

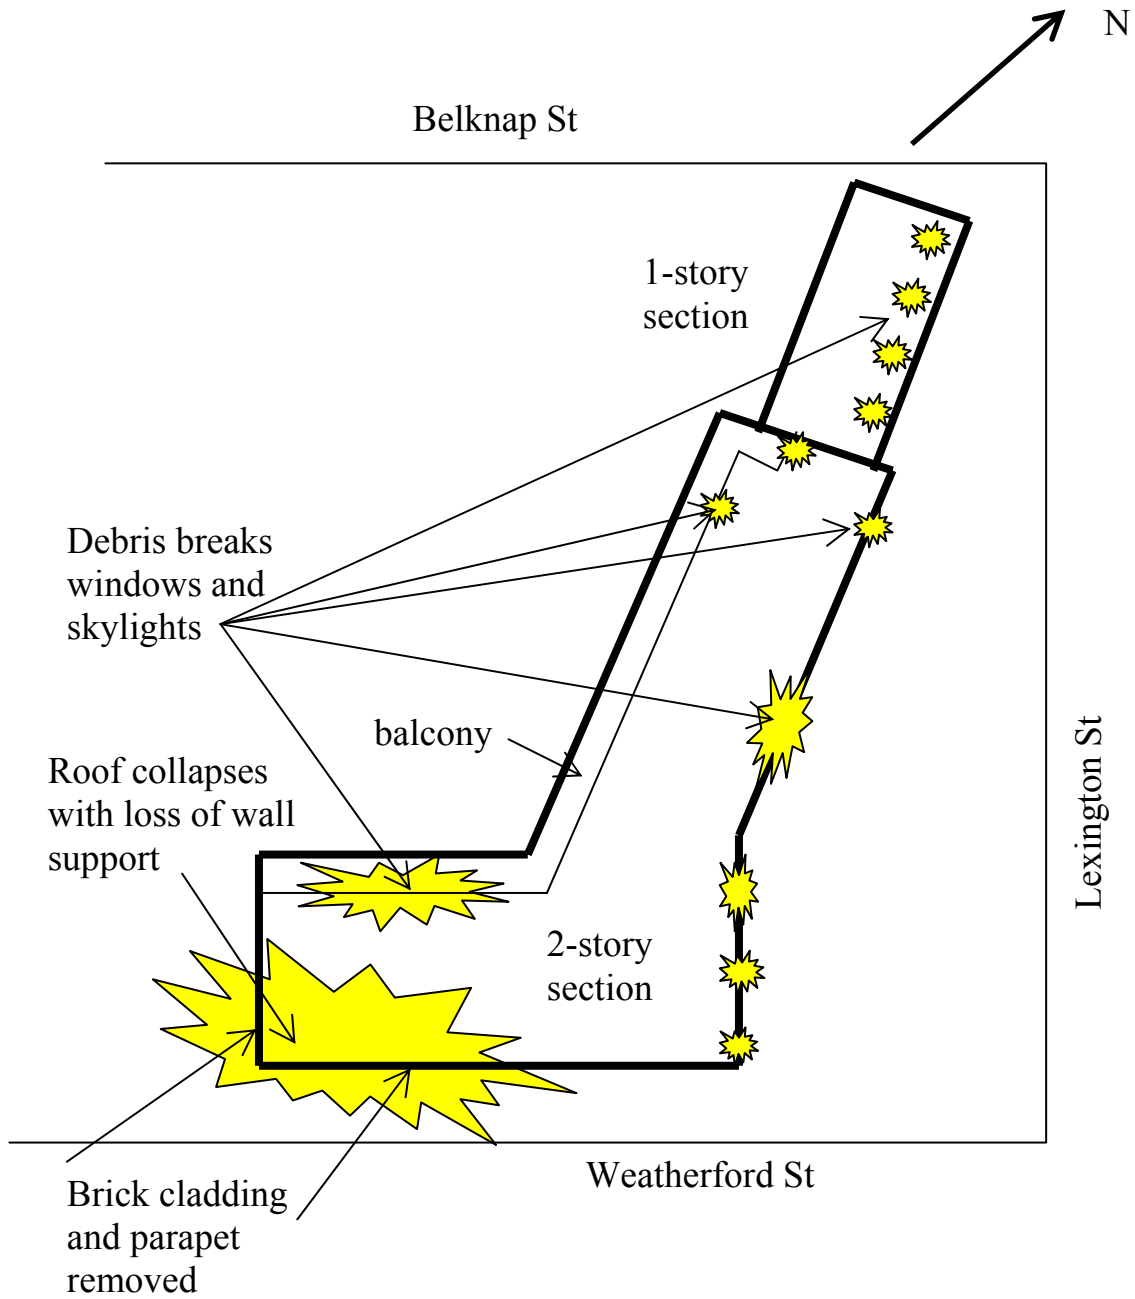
Figure 9. Schematic of damage to Witherspoon building.

The Witherspoon building is a two-story L-shaped structure occupying the southwestern side of Lexington, between Weatherford and Belknap Streets. Figure 9 shows a schematic of the damage to the building. This building suffered major structural failure of the southwest corner including removal of the brick cladding on the southeast face and collapse of the roof over the southwest corner. In addition, there was significant debris damage to glazing on both western and eastern facing walls as well as east facing skylights. The building was very exposed to the west with no structures between it and the river some one-quarter mile to the west. Some trees in the interior of the L afforded some protection from that direction but not sufficient to prevent debris damage particularly at the western and northern extremities of the arms of the L. The postulated failure mechanism is as follows:

- This debris damage on the positive pressure face led to a high internal pressure which, when combined with suction on the Weatherford Street (southeastern) face, led to failure of the cavity brick wall.

- The loss of cladding led to loss of support for the roof in the southwestern corner and subsequent collapse of the roof.
- There was almost complete breakage of skylight windows on the eastern face along with two highly recessed windows, also on the eastern face. This would indicate that wind approached the building from this direction at one stage during the passage of the tornado. In all cases only the outer pane of the double glazed unit failed. The inner panes were safety glass, and although some showed impact markings, the building envelope was not penetrated here.

The building had only two occupants at the time of the tornado, and they were able to take refuge in the basement parking area. The drawing office was severely damaged, and many offices on the northern wing had significant glass debris, although surprisingly little other damage was evident.

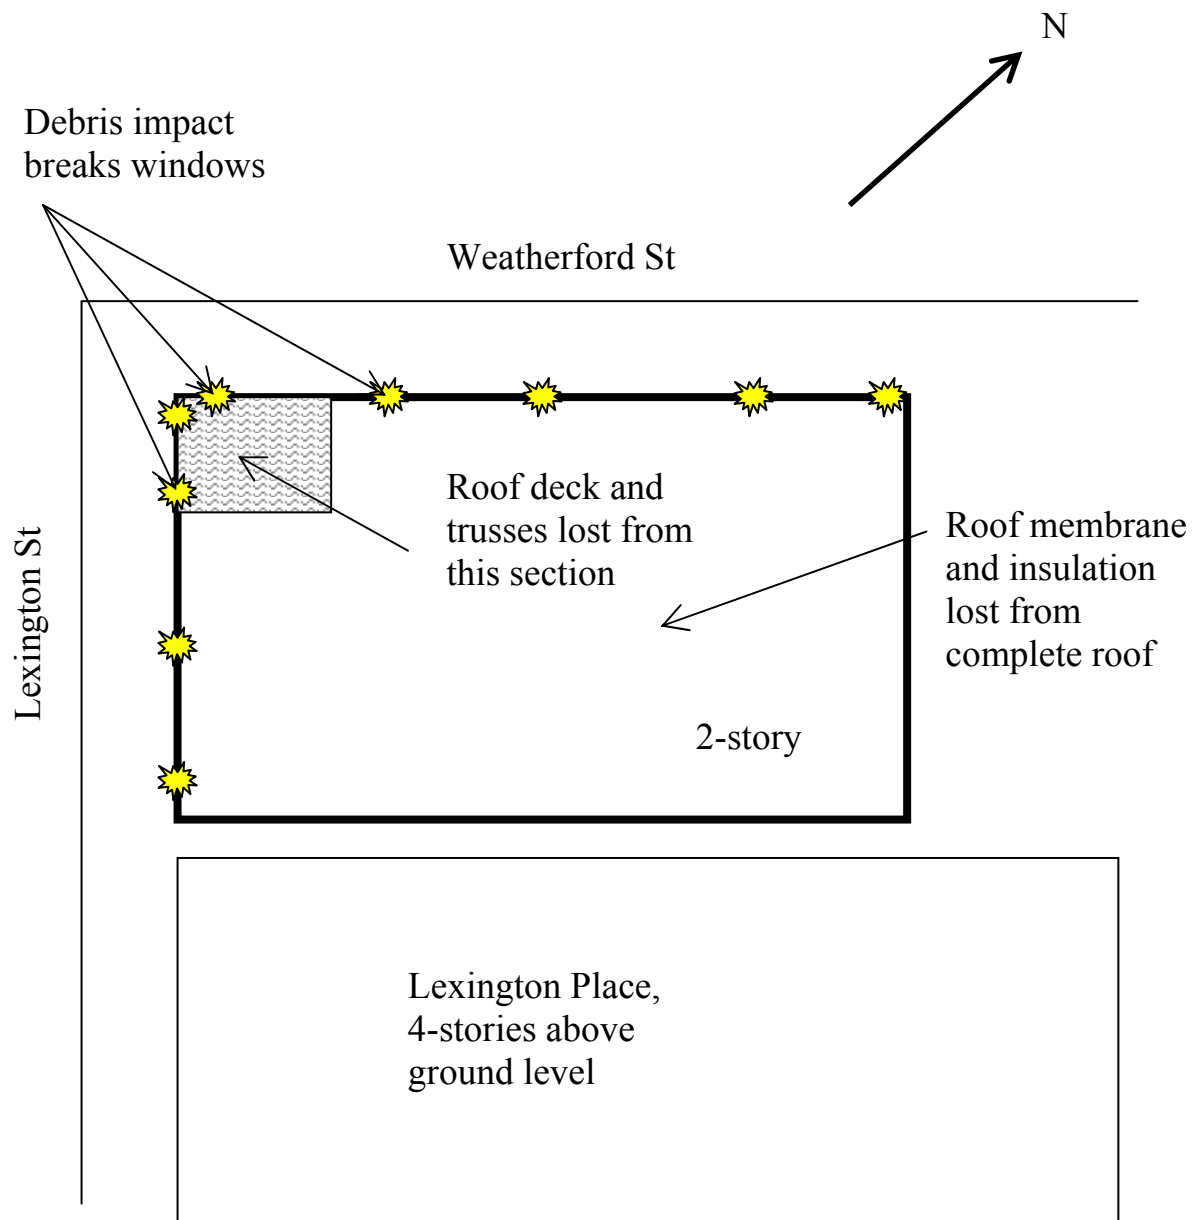
Figure 10. Schematic of damage to 933 Weatherford Building

The two-story building at 933 Weatherford is located on the eastern corner of Weatherford and Lexington Streets, directly opposite the Witherspoon building. Figure 10 shows a schematic of the damage to the building. This building suffered catastrophic failure of the complete roofing membrane and insulation and of the roof deck and roof trusses in the western corner. There was significant glazing damage on the Lexington and Weatherford road frontages. The ground floor level was an open parking area.

- Debris impact breaks windows on western corner of building from whence the tornado approached. Apart from the Witherspoon building and across the street to the northwest, there is clear exposure for this building upwind to the river some one-quarter mile to the west.
- This debris damage on the positive pressure face led to a high internal pressure which, when combined with suction on the roof, lead to failure of the complete roof system, covering and trusses, in the western corner bay.
- Subsequently the complete covering was stripped off the roof.

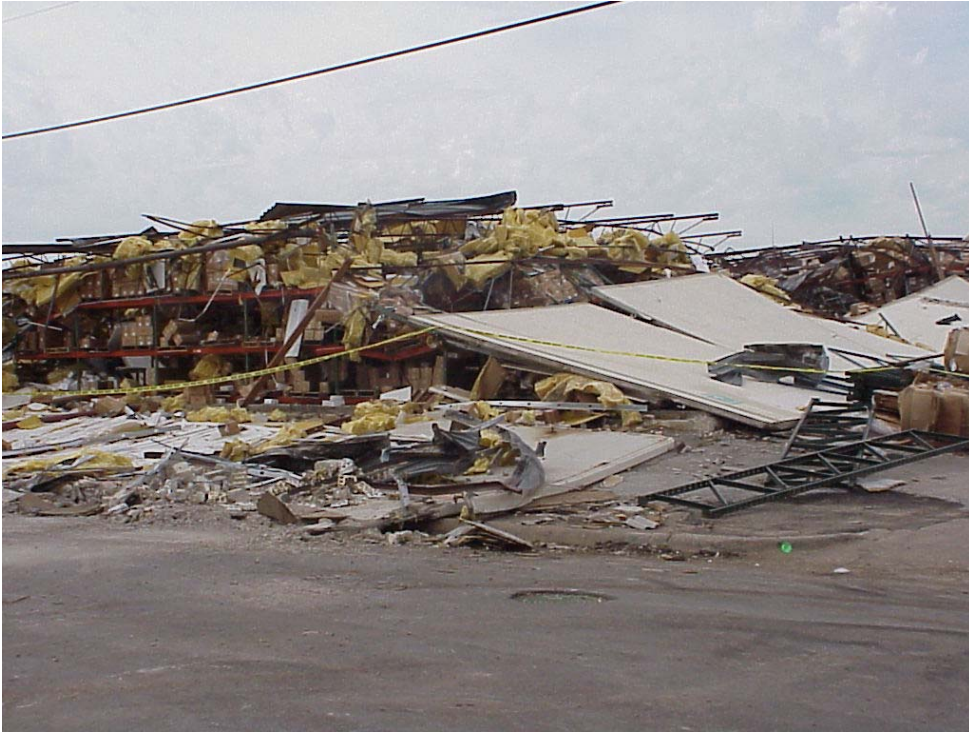
Figure A3. Northeast corner of Sweet Shop Factory.

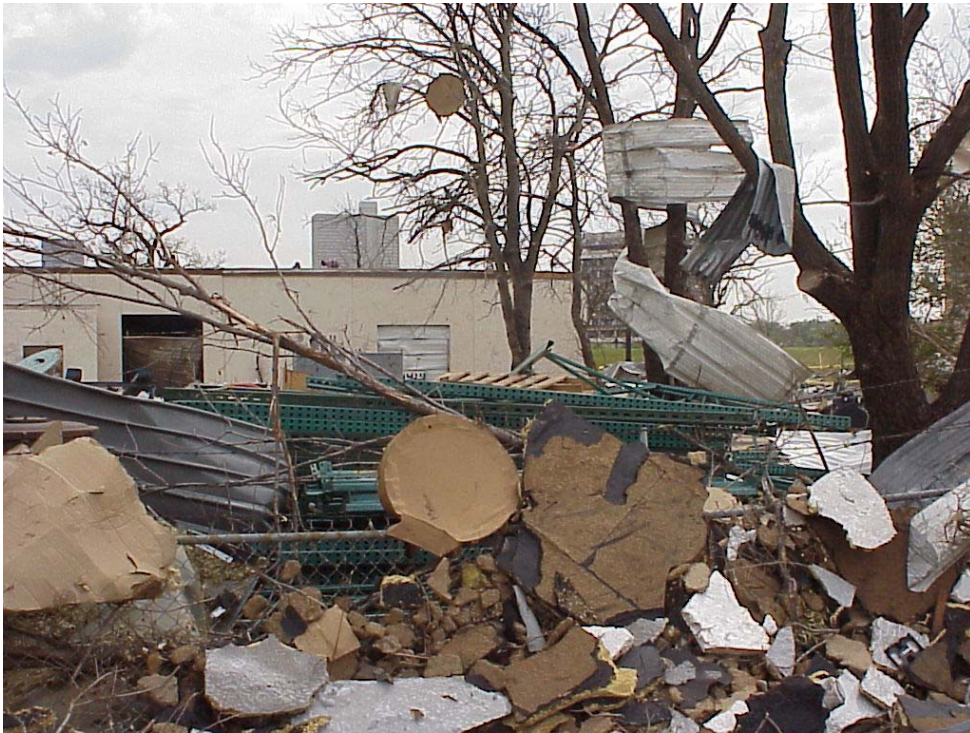
Figure A4. Debris from Johns Manville warehouse in Harrold Street.

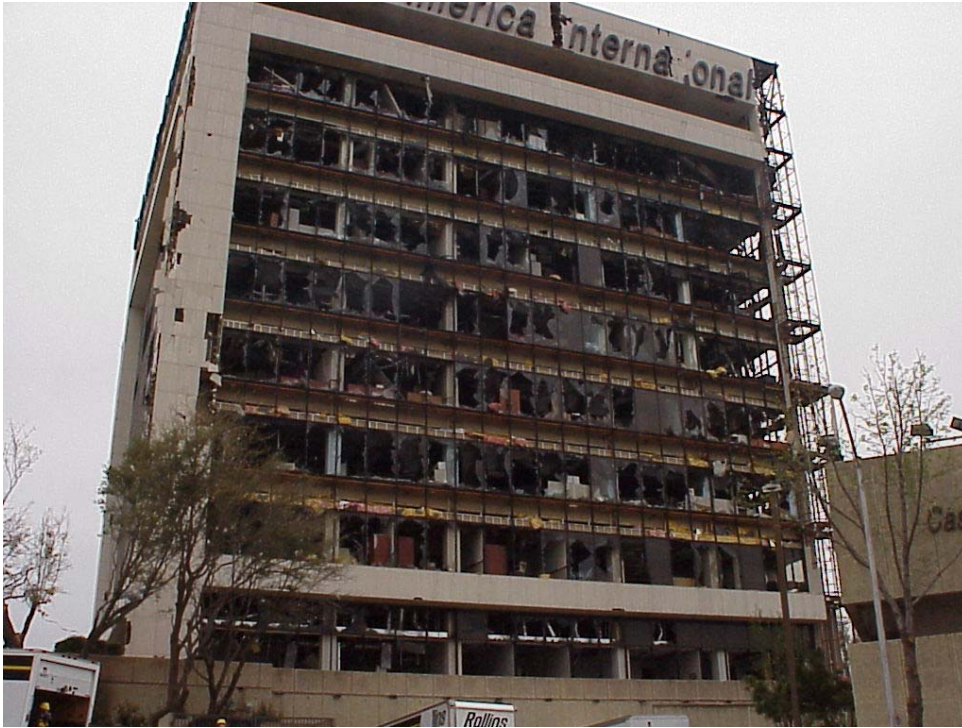
In the Cash America International building, monolithic glass having nominal 6 mm ($\frac{1}{4}$ " thickness glazed both the vision and spandrel areas. The spandrel lites consisted of heat strengthened glass. As the tornado passed, the southwest façade suffered the first impacts. The glass from virtually every fenestration on the southwest façade fractured. Breakage on the southeast façade most likely resulted from several causes as outlined above. These include impact from interior debris, impact from exterior debris, and increased cladding loads because the inside of the building became pressurized as soon and the southwest façade windows fractured. Primarily vision glass fractured on the southeast façade. The vast majority of glass remained in place on the northeast façade, indicating that fewer

Figure A5. Northwest face of Cash America International building.

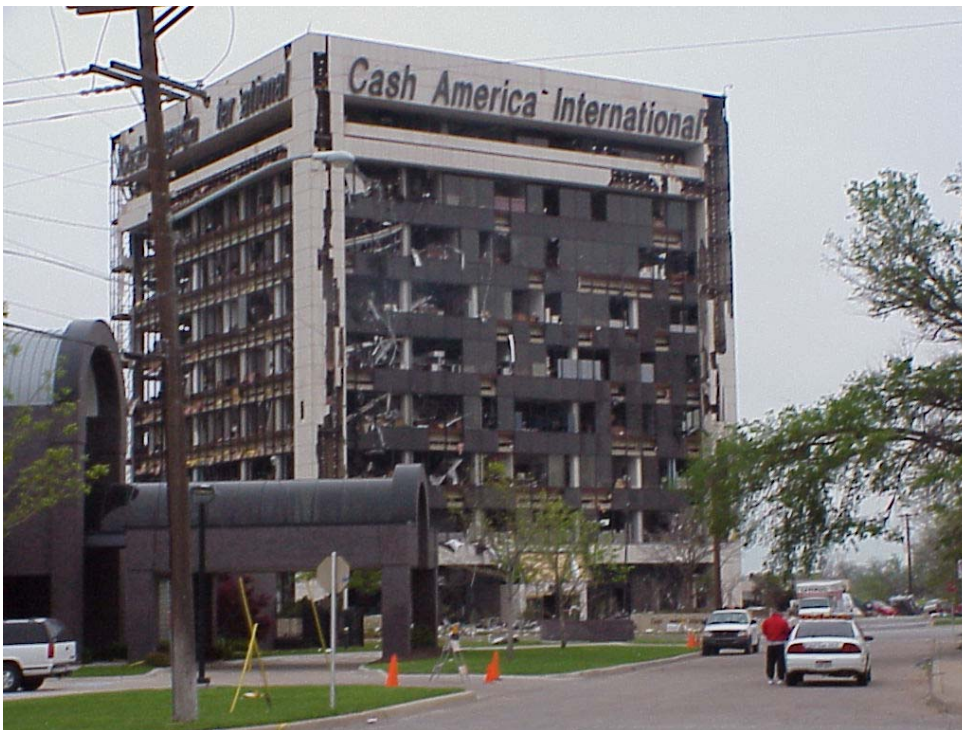
Figure A6. Southwest and southeast faces of Cash America International building, showing internal debris piled up at the south corner.

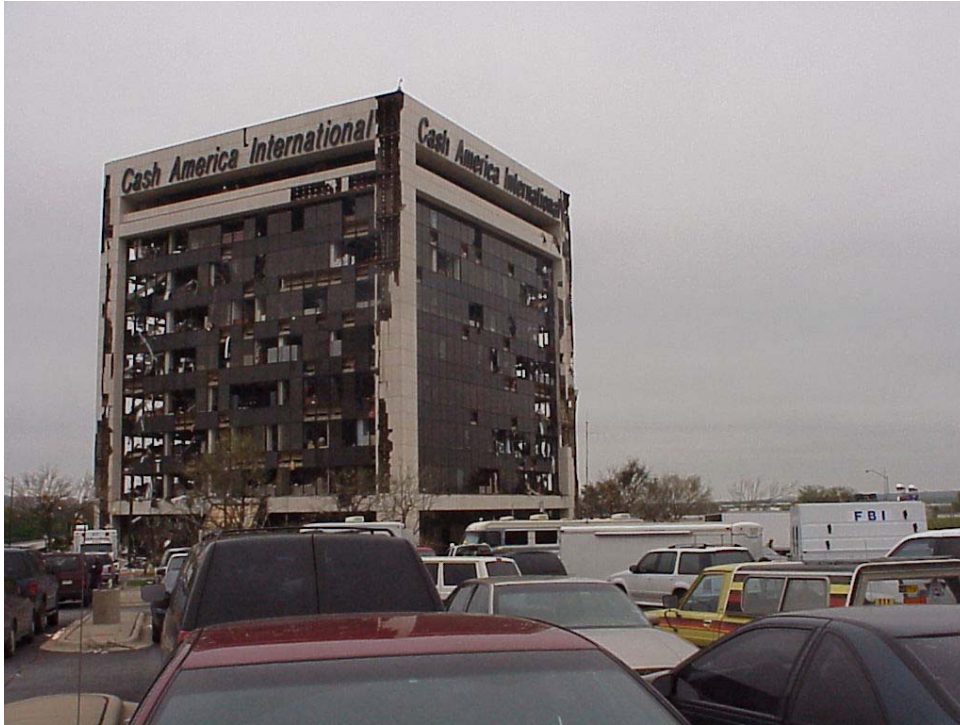
Figure A7. Southwest and northeast faces of Cash America building, showing wind damage in corner regions.

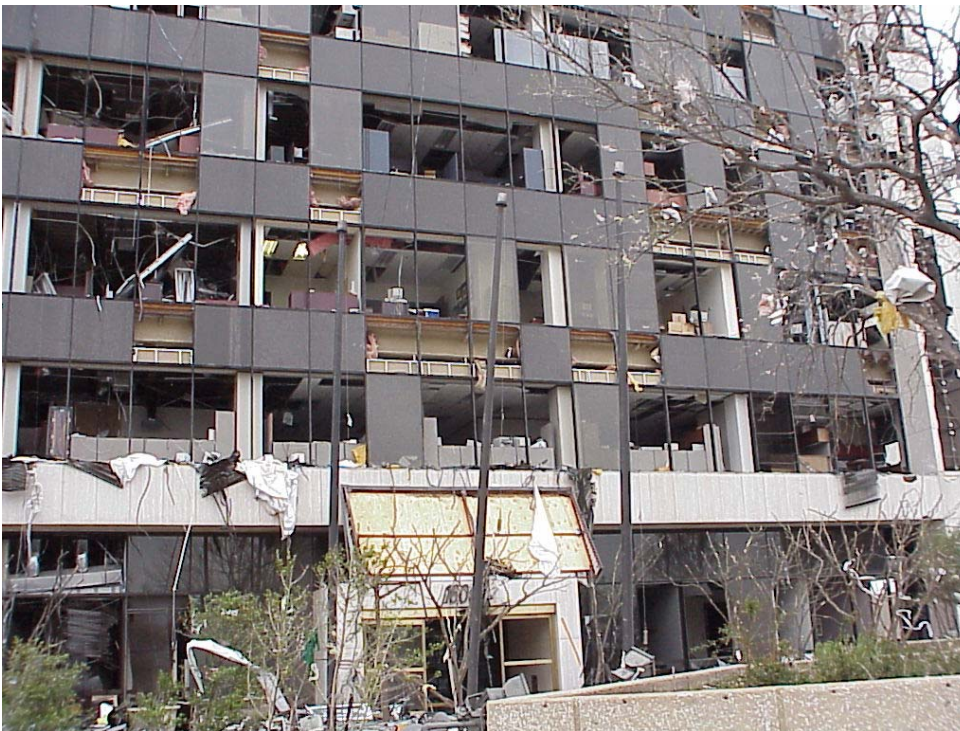
Figure A8. Southeast face of Cash America building showing uplift failure of entrance canopy.

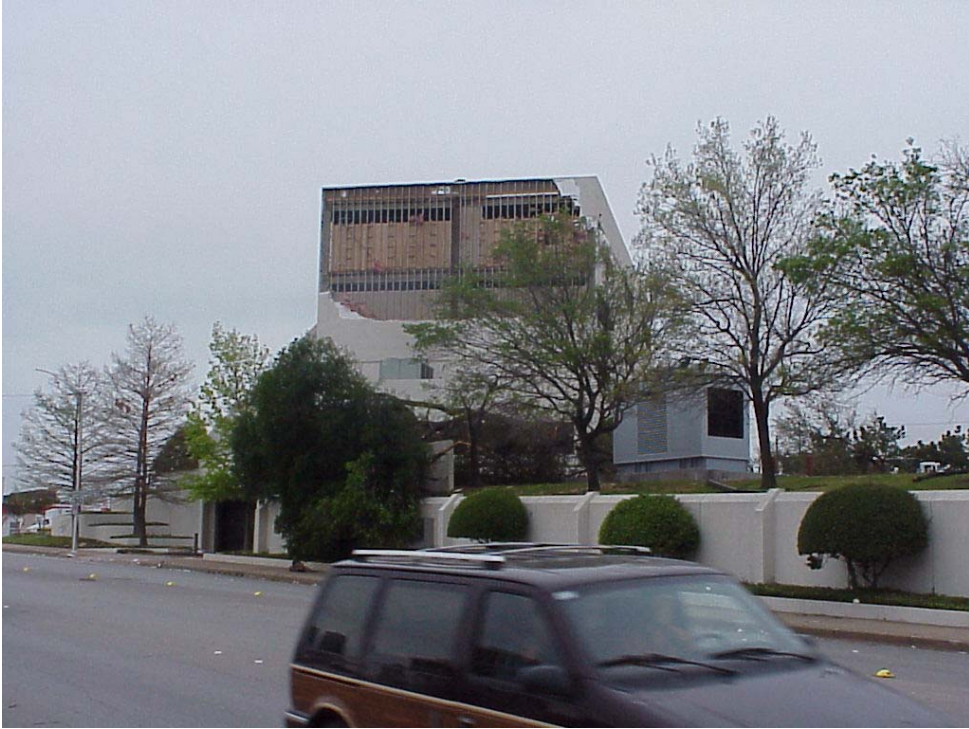
The four-story Educational Employees Credit Union suffered debris impacted broken windows and also loss of EIFS cladding on most of the northwest face and also on the southeast face adjacent to the east corner. It is likely that a combination of suction and internal pressurization lead to the EIFS cladding failures due to the extensive stripping of the cladding from the wall studs. Roof mounted air-conditioning units were also displaced from mounts and the roof membrane was heavily damaged adjacent to corners where conical vortices induced high suctions.

Figure A9. EIFS wall construction failure on northwest face of Education Employees Credit Union.

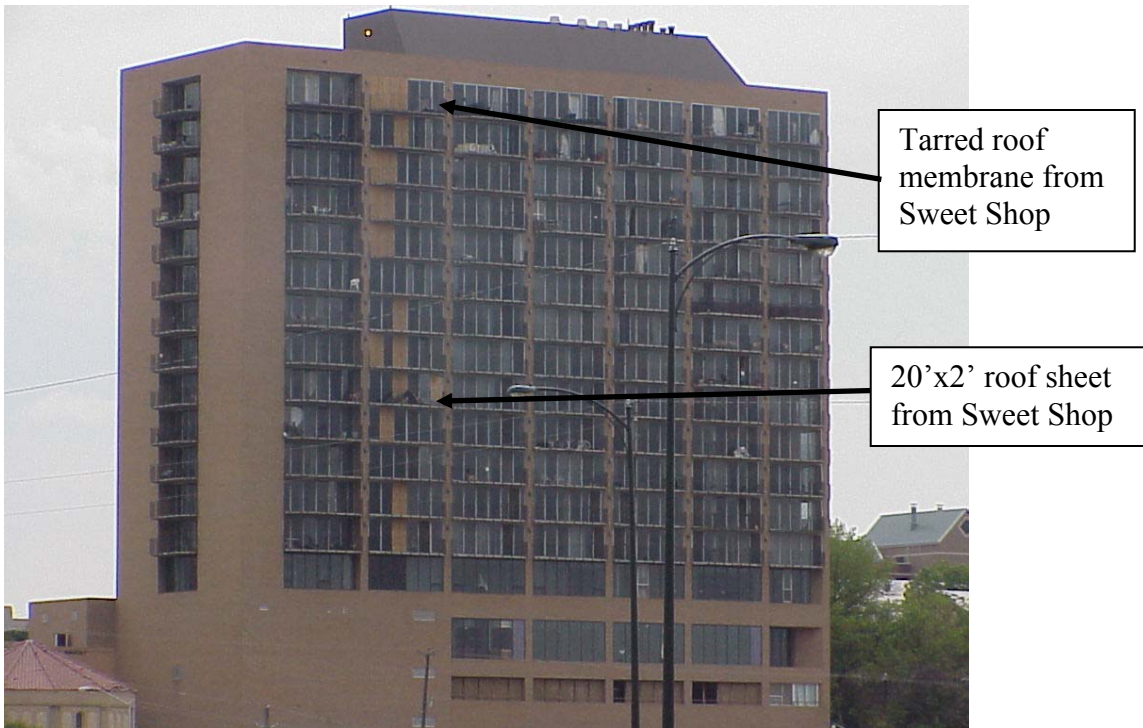
Figure A10. West face of Trinity Terrace.

Tarred roof membrane from Sweet Shop

20'x2' roof sheet from Sweet Shop

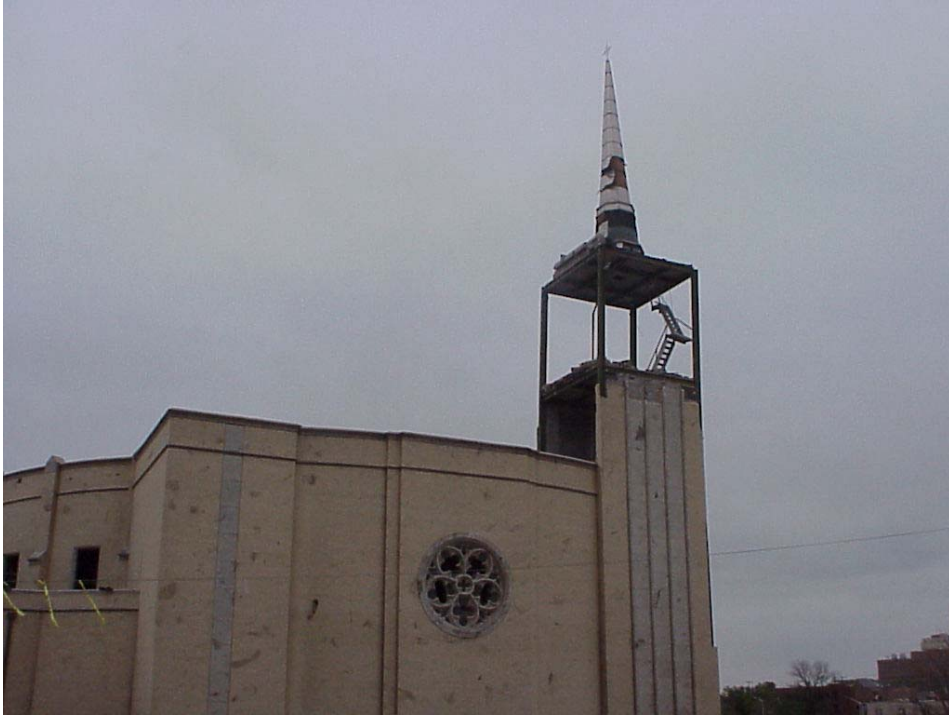
The Calvary Temple church suffered major structural damage to the steeple, with plastic deformation of the steel frame and loss of brick cladding to the top portion and also to the eastern wall of the worship hall. Extensive broken windows and scarring of the brickwork indicated an intense debris field at this point in the tornado. The roof of the extensive two-story classroom section was largely stripped of its membrane cladding and several roof-mounted air-conditioning units traveled across West 5th Street to adjacent parking areas.

Figure A11. Calvary Temple Church steeple failure and impact markings on brickwork.

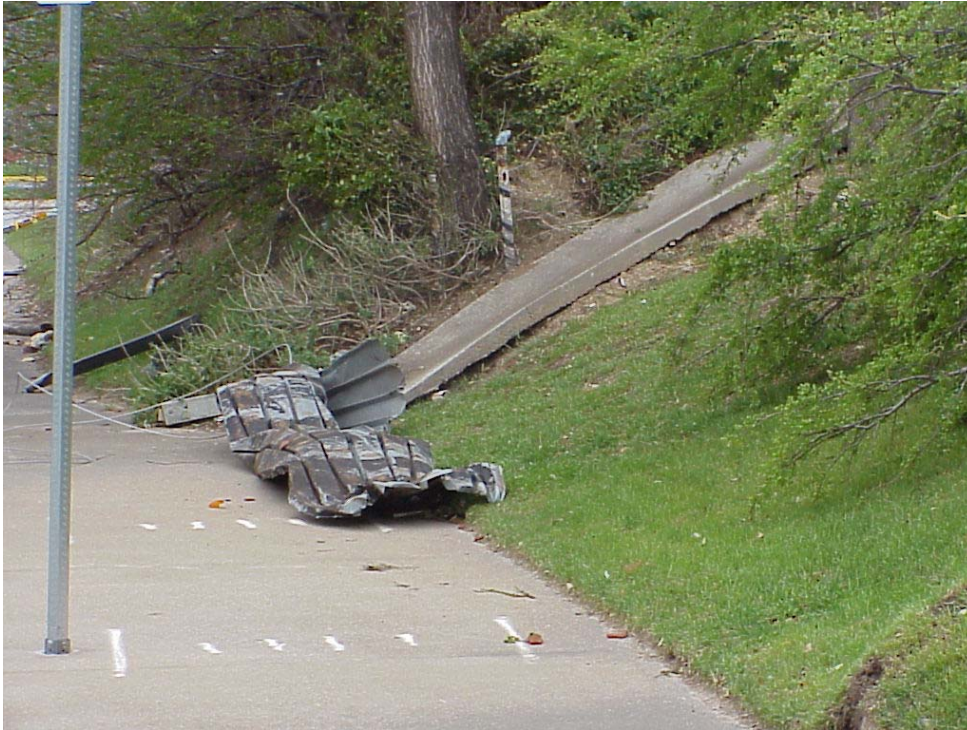
Figure A13. Sweet Shop roof debris on Fournier Street, just south of W 7th Street.

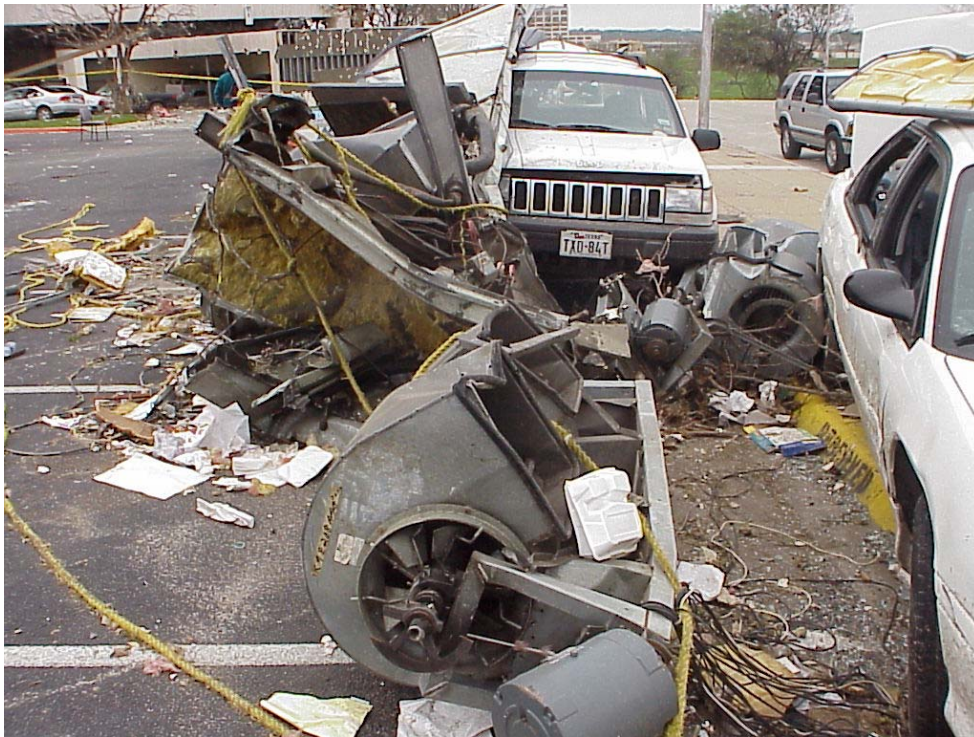
Figure A14. Air-conditioning equipment from the roof of Calvary Temple Church in W 5th Street.

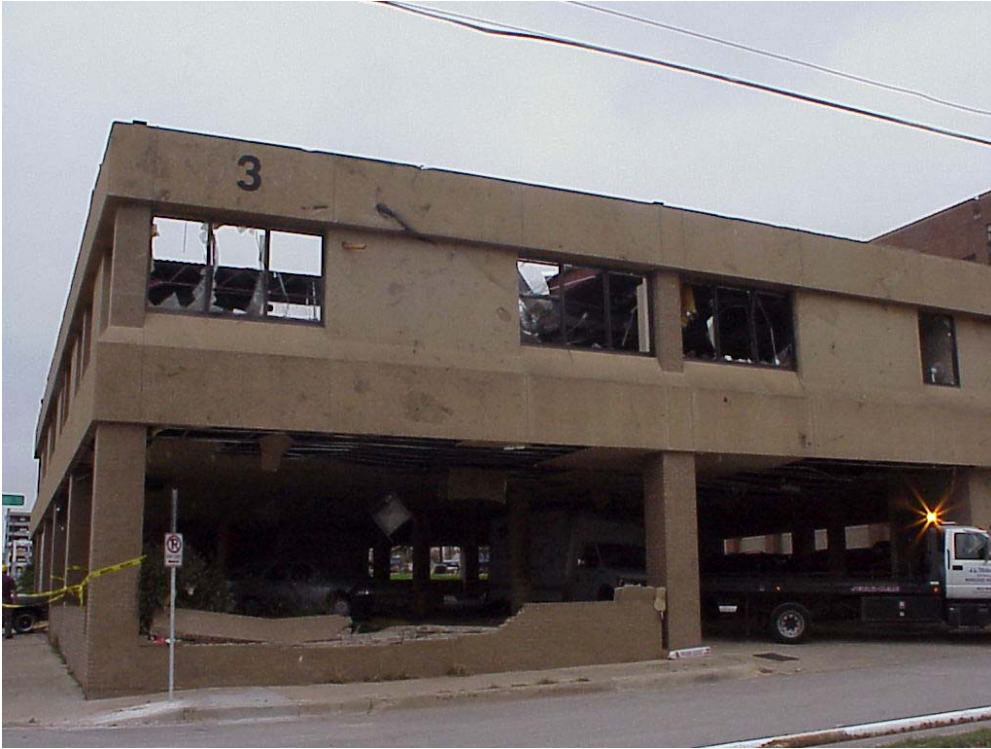
Figure A15. Southwest face of 933 W Weatherford showing failure of roof corner.

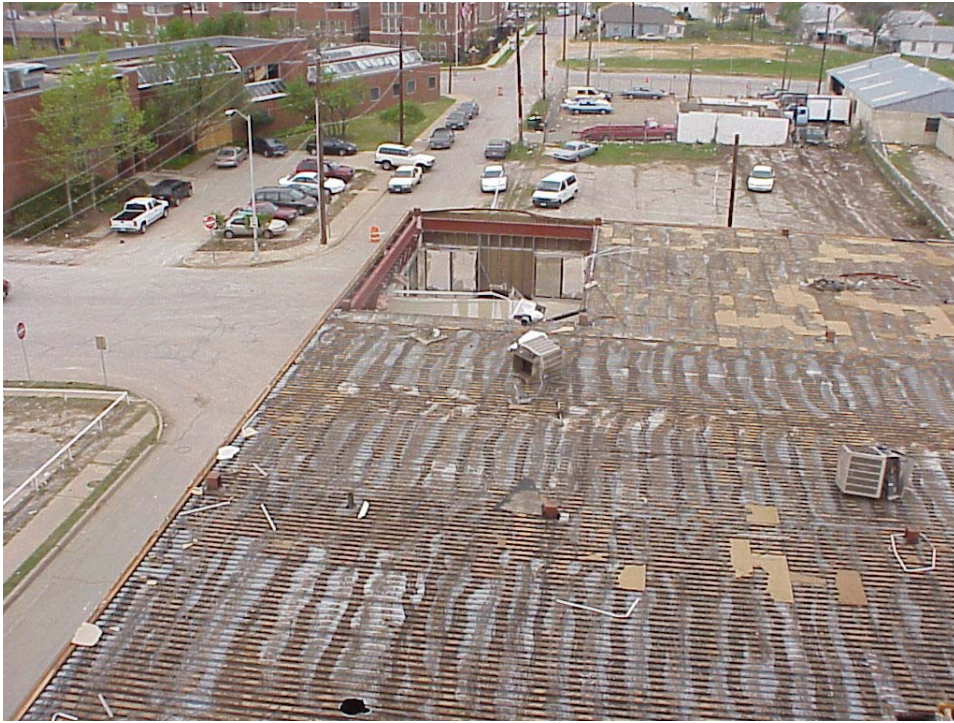
Figure A17. Failure of roofing and corner structure 933 W Weatherford.

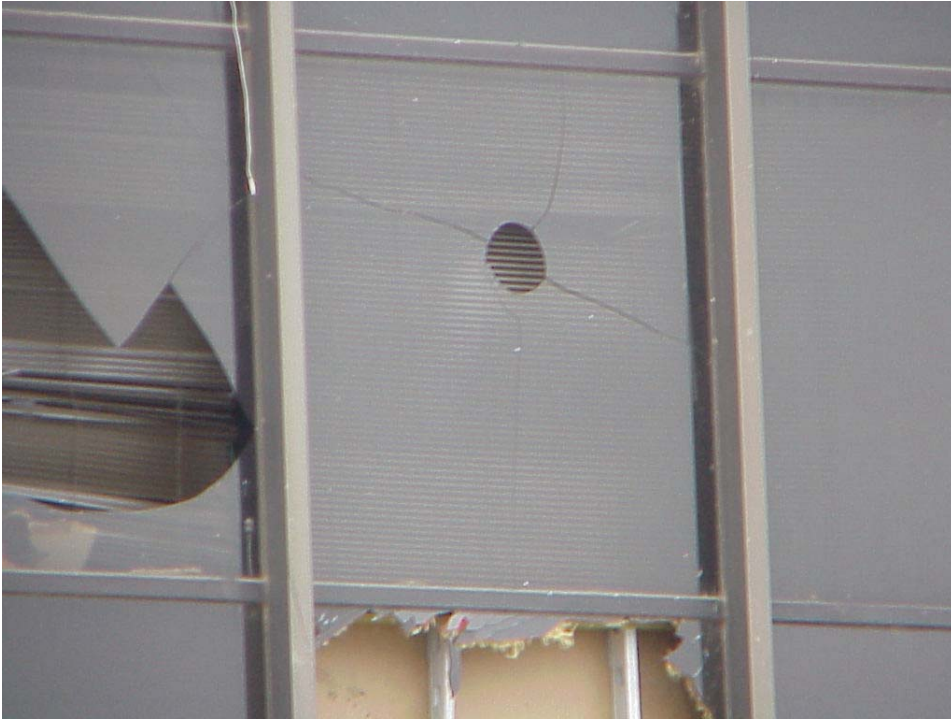
For Mallick Tower, the south and west faces had almost complete fracture of both vision and spandrel lites, while approximately half of the vision lites were broken on the north and east faces. Monolithic annealed glass with nominal 6 mm ($\frac{1}{4}$ ") thickness glazed the curtain wall of Mallick Tower. The vision lites consisted of annealed glass and the spandrel lites consisted of heat-strengthened glass. Oddly, slightly more spandrel glass than vision glass fractured on the north face, while this was reversed for the east face. Investigators received permission to enter Mallick Tower. The interior suffered very significant wind and water damage. Tenants were moving damaged belongings from their offices. Scrape markings on the top of the Mallick Tower parapet from built-up roof construction indicated that the debris field was populated with large pieces and the glazing had little chance of survival.

Figure A19. Debris impact Point in vision glass on Mallick Tower.

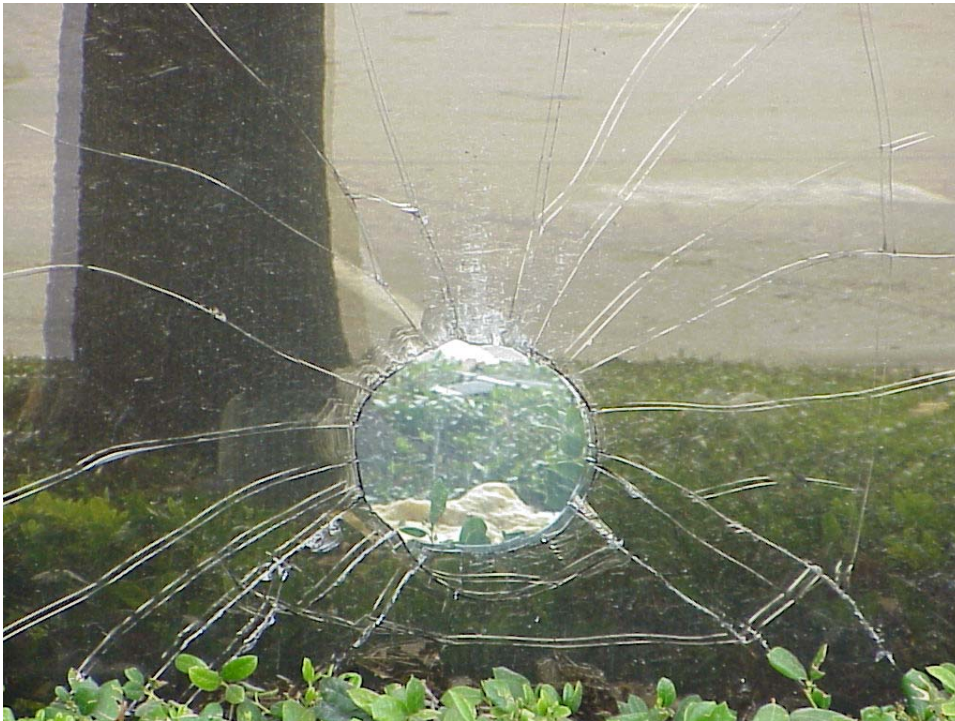
Figure A20. Impact fracture on outer lite of insulating glass unit on the ground floor of INSpire Insurance Building, southwest façade.

Several glazing possibilities exist that will reduce the probability of breaching the building envelope in a windstorm. At a first level, glazing with sealed insulating glass (IG) provides one level of protection for short duration windstorms. Insulating glass consists of two plies of glass around a sealed air space. The outer lite of the IG serves as a sacrificial ply and protects the interior lite. As long as the interior lite does not fracture, the IG unit will maintain closure of the building envelope, keeping wind and rain out of the building. Under a long duration, severe windstorm, repeated impacts can fracture the interior lite of the IG unit and open the building envelope. While increasing protection minimally, IG units made with two lites of monolithic glass offer only a marginal increase in protection against windborne debris impact. Insulating glass, as its name implies, provides additional benefits to any building it glazes with respect to energy savings.

At a next level, glazing with laminated glass (LG) provides a high level of protection in maintaining closure of the building envelope in a severe windstorm. Laminated glass consists of two plies of glass bonded together by an elastomeric interlayer. Laminated annealed glass, when fractured, will tend to remain in the frame. If secured to the frame with glazing tape or structural silicone sealant, LG provides a very high level of protection. For even more protection, IG fabricated using LG in one or both lites provides the most protection available using standard glazing products.

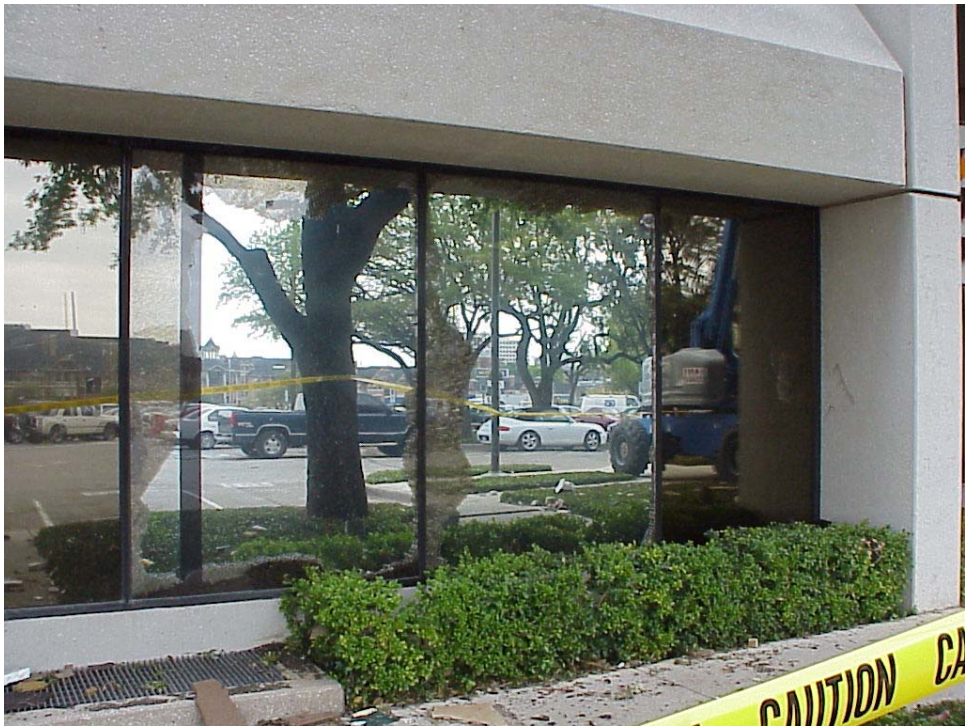
Figure A22. Broken outer lites of insulating glass units on ground floor of INSpire Insurance Building, southwest façade.

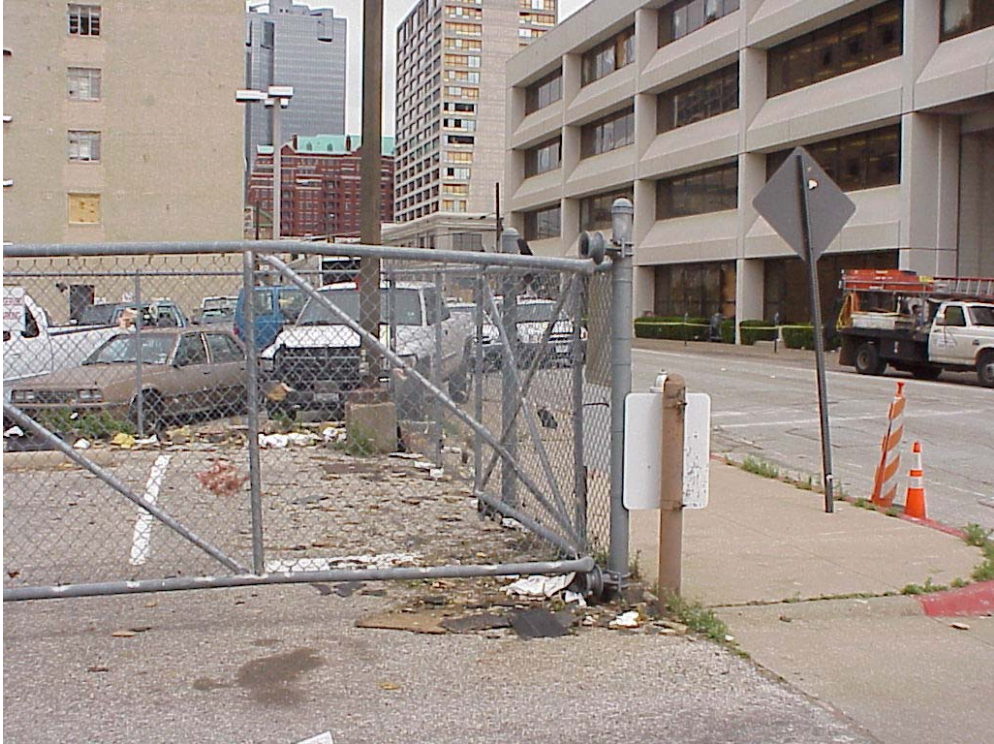
Figure A23. Bent GI gate on 2nd Street adjacent to Hunter Plaza, bent towards north.
